Name Of Dam: LOWER NORTH RIVER, NO. 22B

Location: ROCKINGHAM COUNTY, STATE OF VIRGINIA

Inventory Number: VA 16504

PHASE I INSPECTION REPORT NATIONAL DAM SAFETY PROGRAM

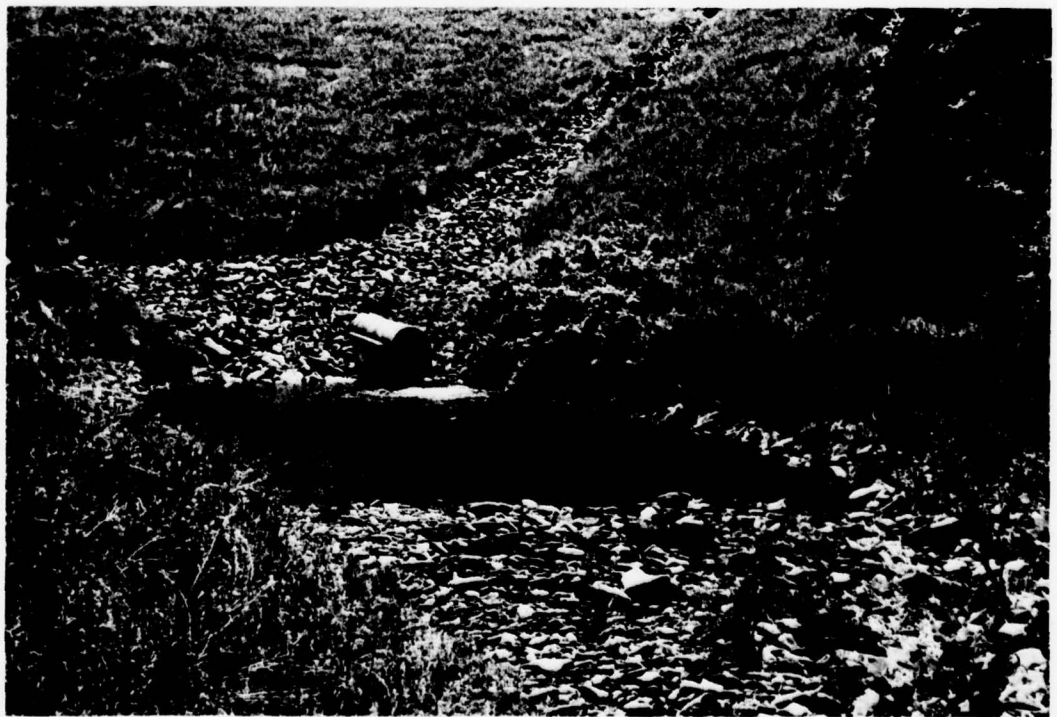
PHOTO 4

About seven feet of the stilling basin side-walls' riprap has washed into the basin. Photo 4 is a view of the stilling basin. This old riprap should be removed from the basin and replaced by larger rocks and filter bedding or filter cloth to prevent further erosion.

5.3 Flood Experience: Highwater debris marks on the upstream face of the embankment, shown in Photo 3, indicate that the water level has risen to approximately an elevation of 1994. Based upon the S.C.S. design, the storm would have a 25 year flood or a four percent probability. As referenced previously upon examination of the outlet works, the stilling basin shows signs of erosion caused by large discharges indicated in Photo 4.
